**Former Elementis  
Pigments Facility  
1525 Wood Avenue  
Easton PA**

**PADEP Northeast Regional Office,  
EPA Region III**

**03 September 2025**

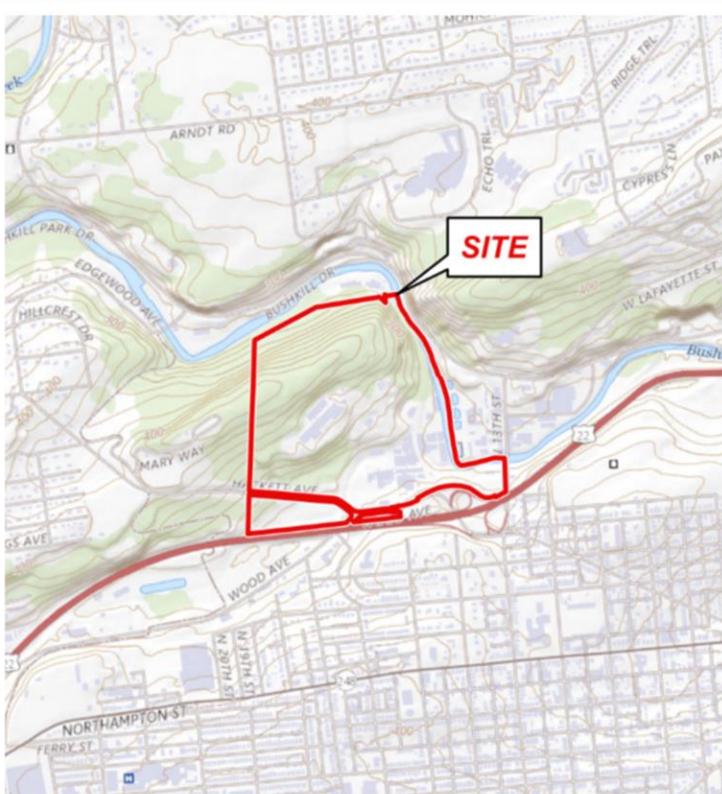
# SITE BACKGROUND & HISTORY

- 114-acre industrial site, Wood Avenue, Easton, Northampton County, PA
- 1876: Commenced operations by C.K Williams Company processing locally mined ore
- 1940s: Start using pickle liquor and scrap steel to produce synthetic iron oxides
- Processes onsite included iron oxide, magnetic iron oxide, black oxide and contact sulfuric acid manufacturing
- 1998: Elementis Pigments purchase- continued manufacture of iron oxide pigments
- 2021: Abruzzi Trust purchase – current owner
- 2018-Present: All buildings demolished
- Residential, light industrial/commercial surrounding land use

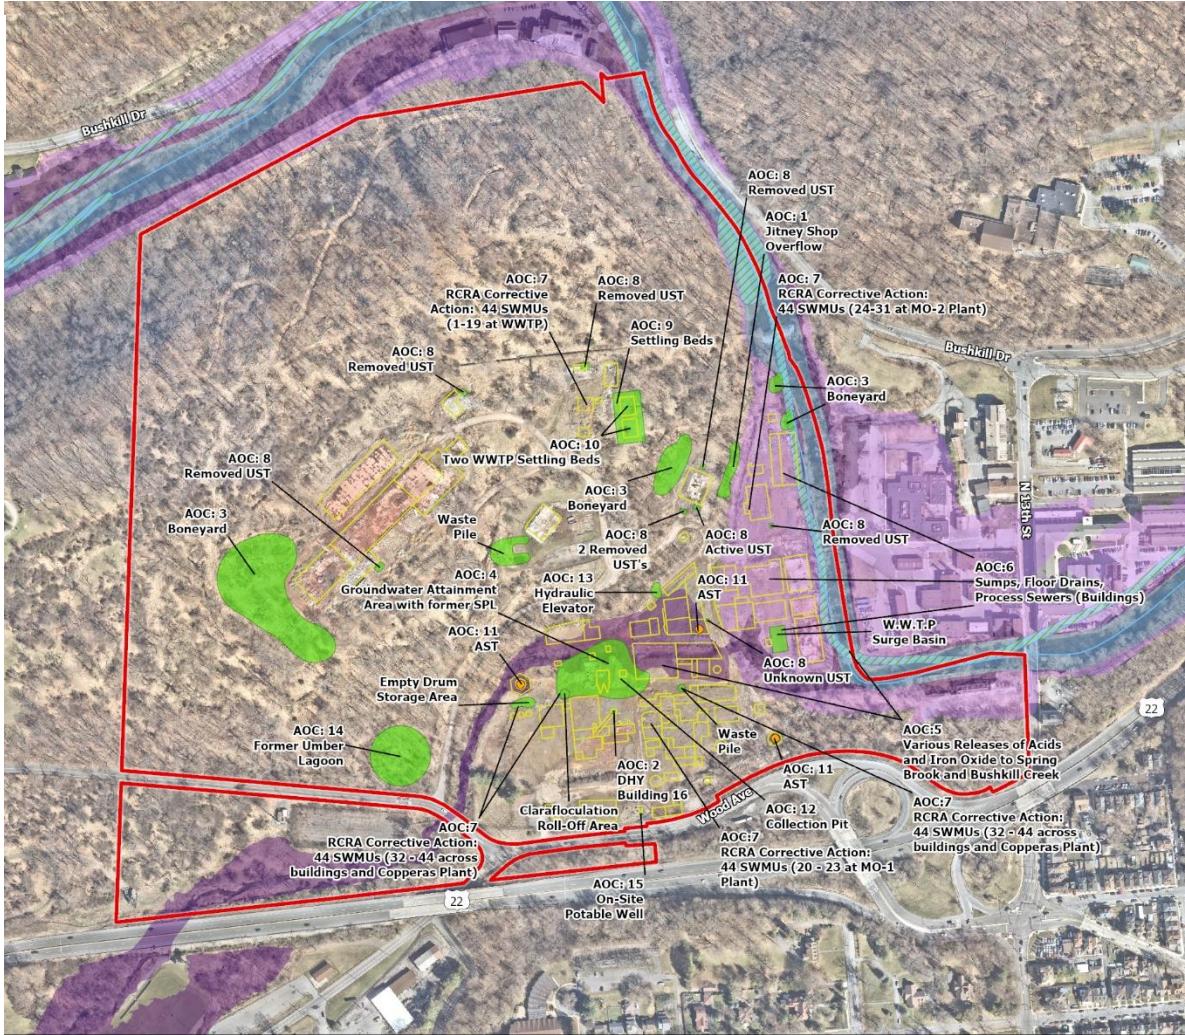
# ENVIRONMENTAL HISTORY

| <b>AOC-1</b> | Wast Oil Tank, Jitney Shop, Building 118, Discharge to Drainage Swale |
| <b>AOC-2</b> | DHY Building 16, Rainwater in Circuit Breaker Room |
| <b>AOC-3</b> | Boneyard, west of Finishing Plant Tank Farm (Building 125) |
| <b>AOC-4</b> | Groundwater Contamination with SPL |
| <b>AOC-5</b> | Various releases of acids and iron oxide to Spring Brook and Bushkill Creek |
| <b>AOC-6</b> | Sumps, Floor Drains, Process Sewers |
| <b>AOC-7</b> | RCRA Corrective Action - 44 SWMU and 1 AOC |
| <b>AOC-8</b> | USTs |
| <b>AOC-9</b> | Settling Beds |
| <b>AOC-10</b> | Wastewater Treatment Plant Settling Beds |
| <b>AOC-11</b> | ASTs |
| <b>AOC-12</b> | Collection Pit, breaches due to corrosion |
| <b>AOC-13</b> | Hydraulic Elevators (2), may contain PCBs |
| <b>AOC-14</b> | Former Umber Lagoons |
| <b>AOC-15</b> | On-Site potable well |

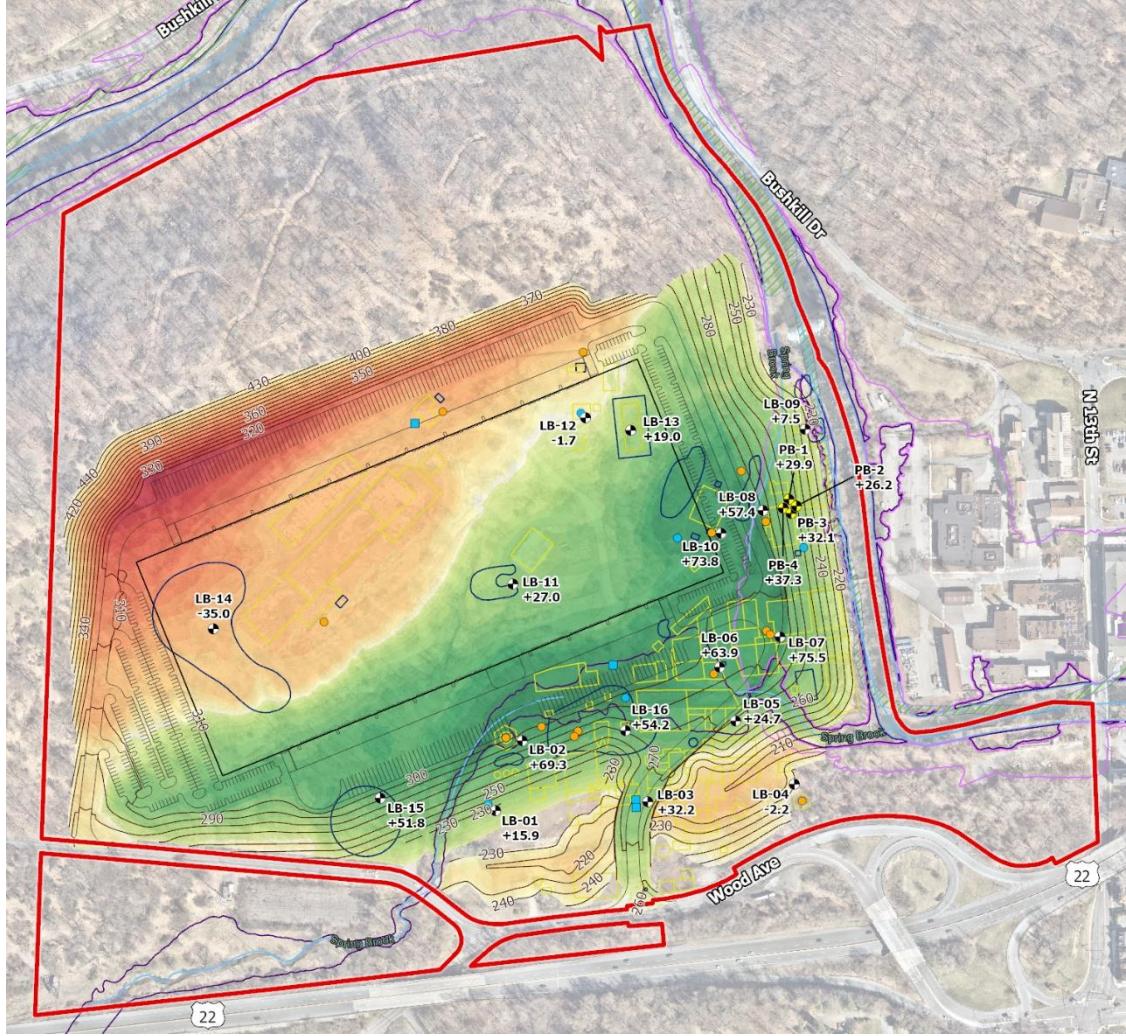
# REDEVELOPMENT PLAN

## Cut Fill Thickness (Feet)

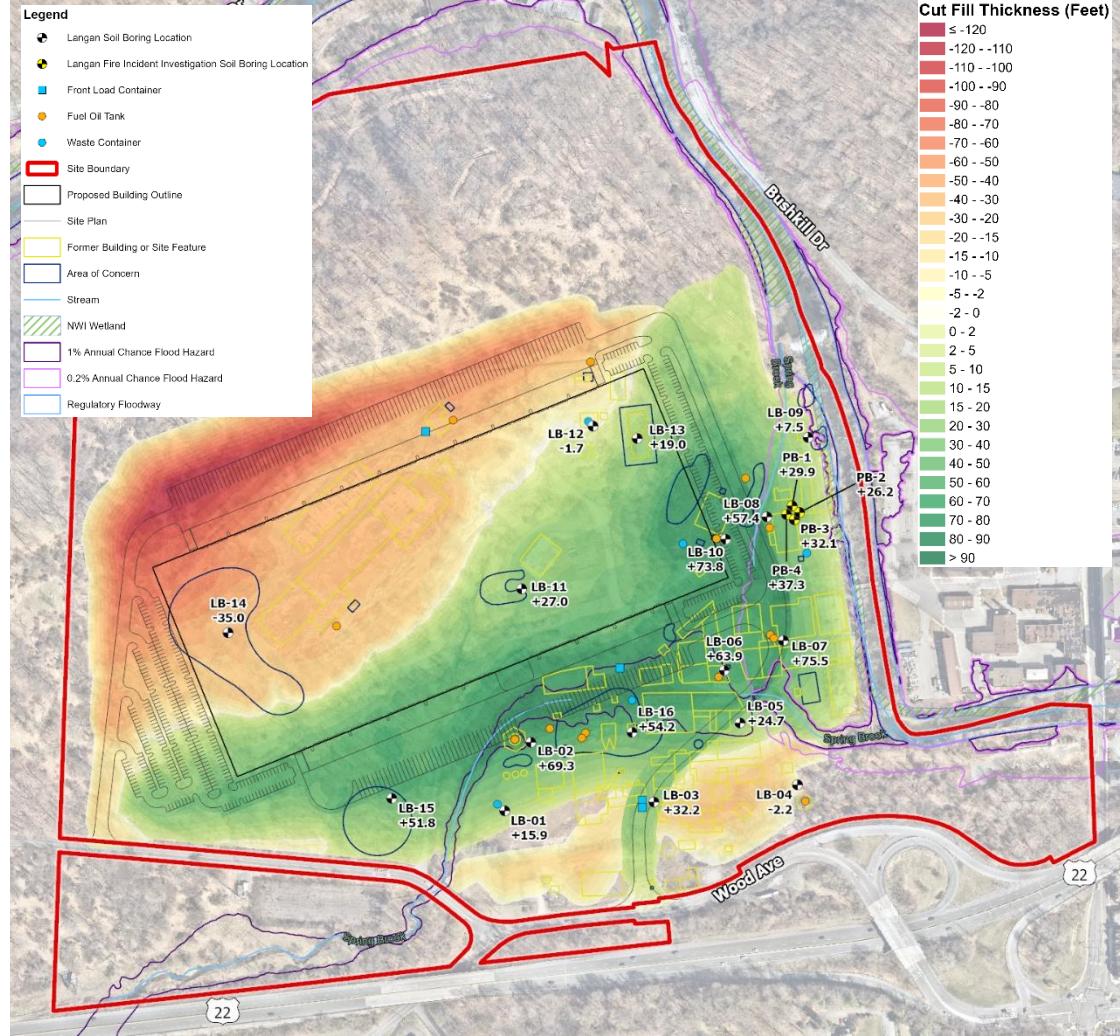
# PADEP ACT 2 REMEDIAL INVESTIGATION - SOIL

- Metals are the primary COCs, as expected
- Antimony, cobalt, nickel, lead, manganese and arsenic exceeded the applicable PADEP Soil to GW Non-Residential SHS
- Iron exceeded the applicable PADEP Soil 0-2 Direct Contact Non-Residential SHS
- PFOA, PFOS and PFBS were not detected above laboratory detection limits, below PADEP MSCs

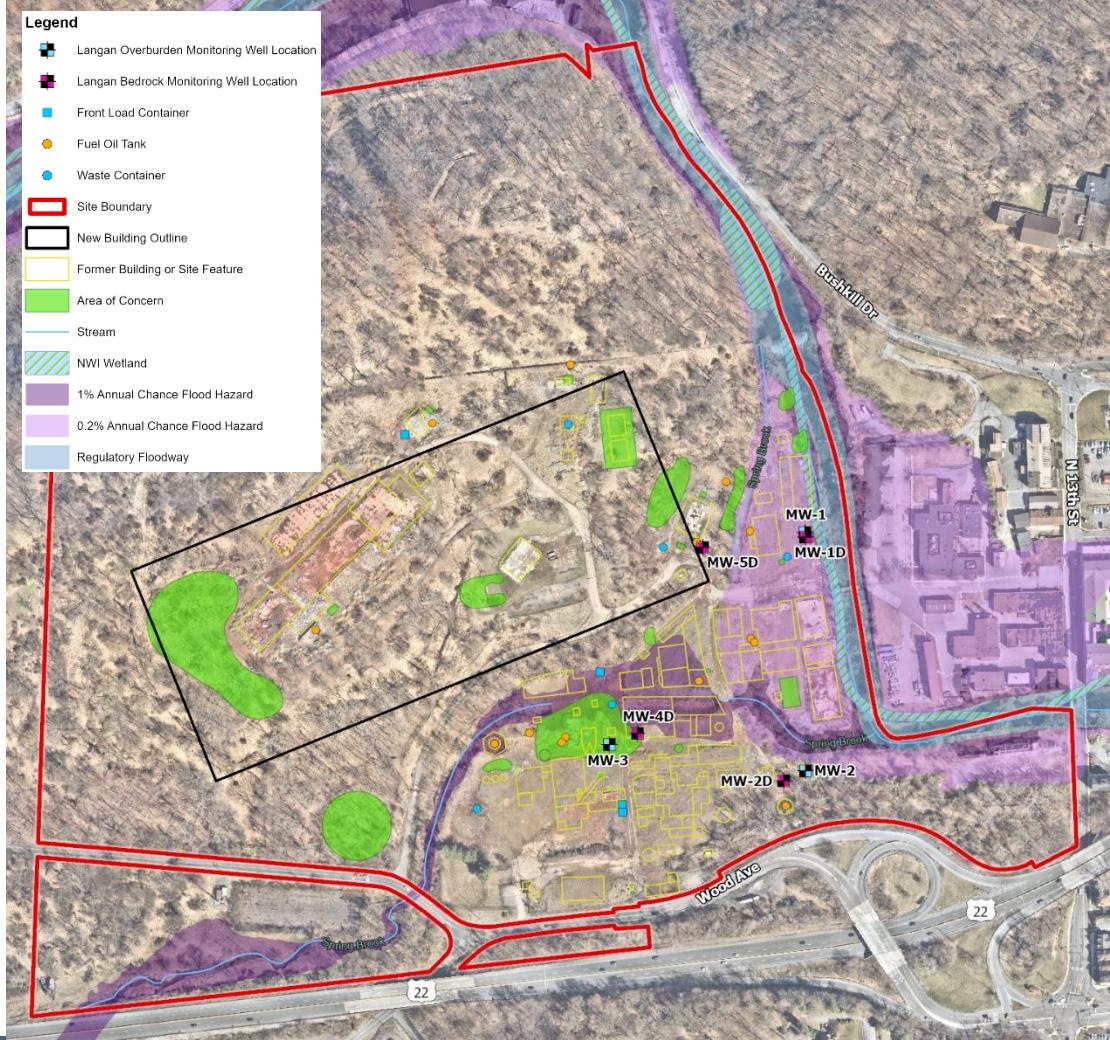
# PADEP ACT 2 REMEDIAL INVESTIGATION - GROUNDWATER

- 4 rounds of sampling
  - Analyzed Parameters: VOCs, SVOCs, PCBs, TAL Metals
  - Metals: Manganese, iron aluminum, beryllium, cobalt and nickel were detected above the PADEP Residential and Non-Residential GW SHS.

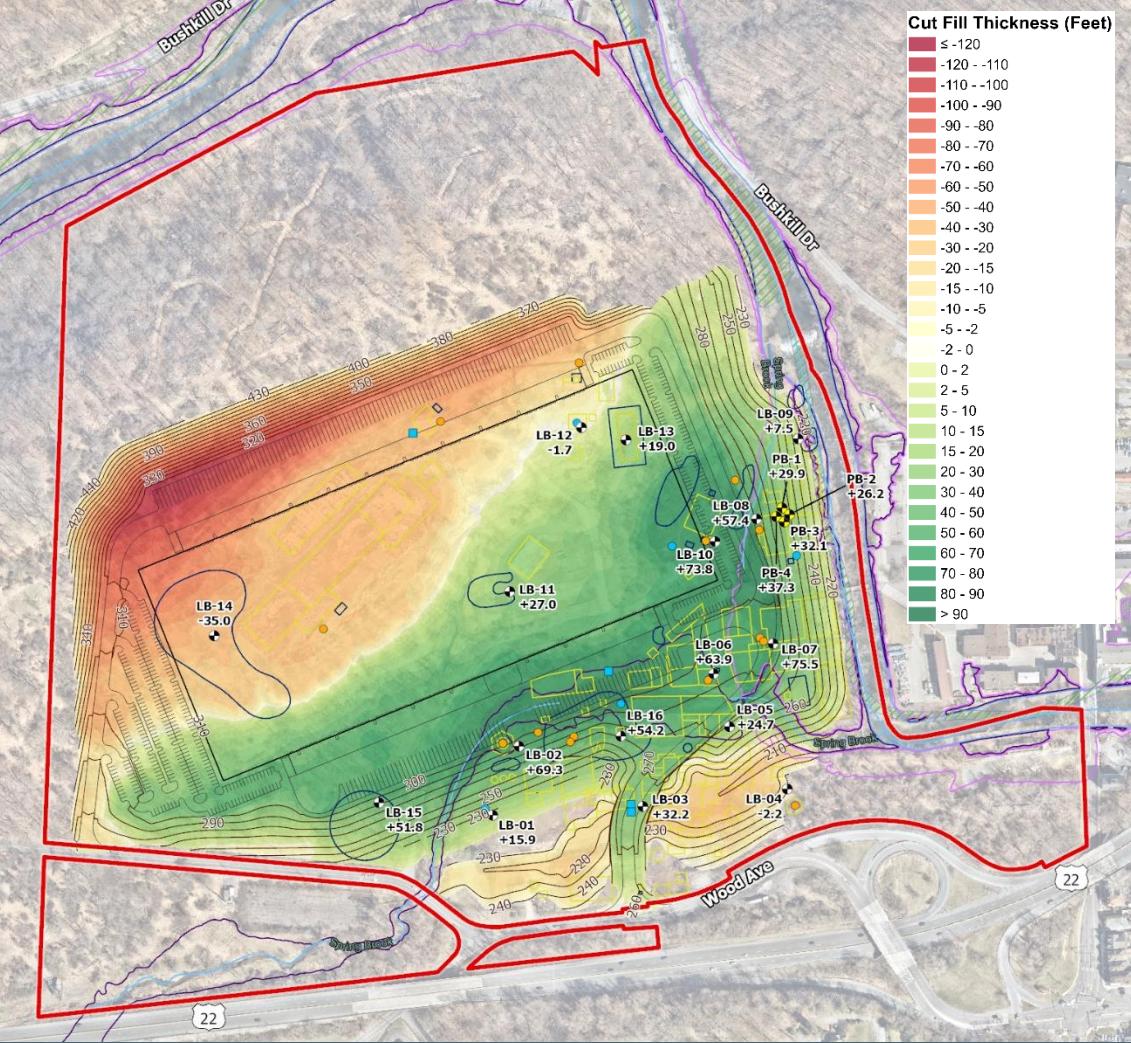
# CLEAN-UP PLAN

Cleanup to be Integrated with Site Redevelopment – Fill Areas > 15'

- Materials Management Plan
- Post-Remediation Care Plan
- Environmental Covenant, Activity and Use Limitation (AUL)
- Groundwater Restrictions
